Investigation Report 431/15

**Serious Marine Casualty**

**Serious engine damage  
followed by fire  
on board the cargo vessel THETIS D  
on 26 October 2015  
in the Kiel Bight**

14 June 2018

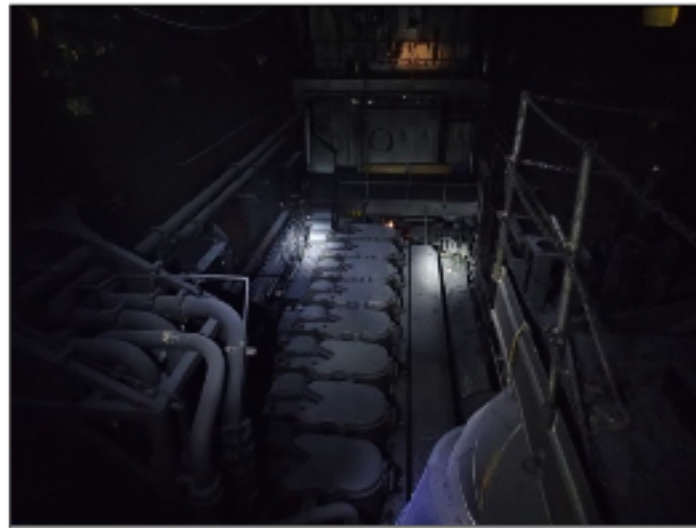
Figure 3: View of the main engine (taken on 27 October 2015)

The BSU's investigation team carried out an initial survey on board in the port of Kiel Ostuferhafen on 27 October 2015. At this point, the engine room only had makeshift lighting because the fire had destroyed most of the lights (see Fig. 3).

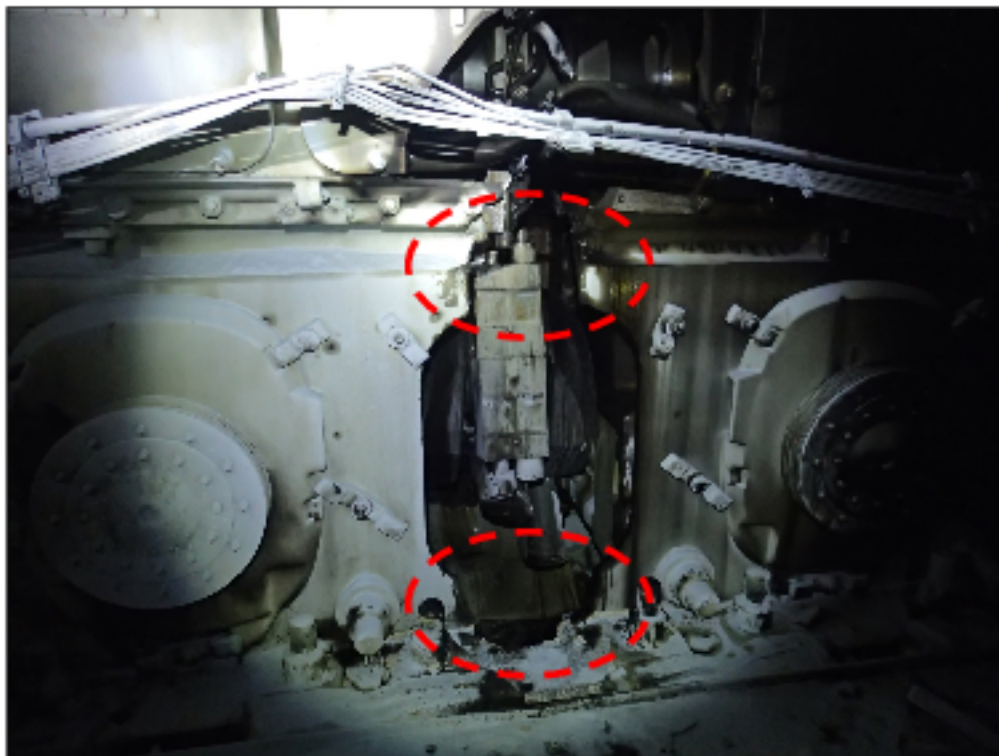
Figure 4: Cylinder 7's drive unit opening (taken on 27 October 2015)

It was found during a visual inspection of the main engine that the drive unit openings on both sides of cylinder 7 exhibited considerable damage. The maintenance cover had been blasted off on both sides and large fragments of the engine frame had broken away (see Fig. 4).

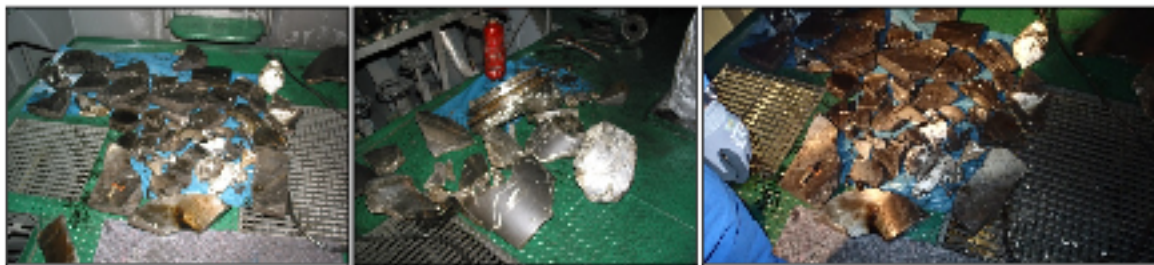
Figure 5: Sorted debris (taken on 3 November 2015)

The BSU commissioned an expert with a detailed investigation of the engine damage and carried out another survey of the THETIS D with him on 3 November 2015. The THETIS D's engine room personnel were interviewed during this survey. In the meantime, a certain amount of cleaning and clearing work had already taken place in the engine room. The debris had been divided into groups of individual components (see. Fig. 5).

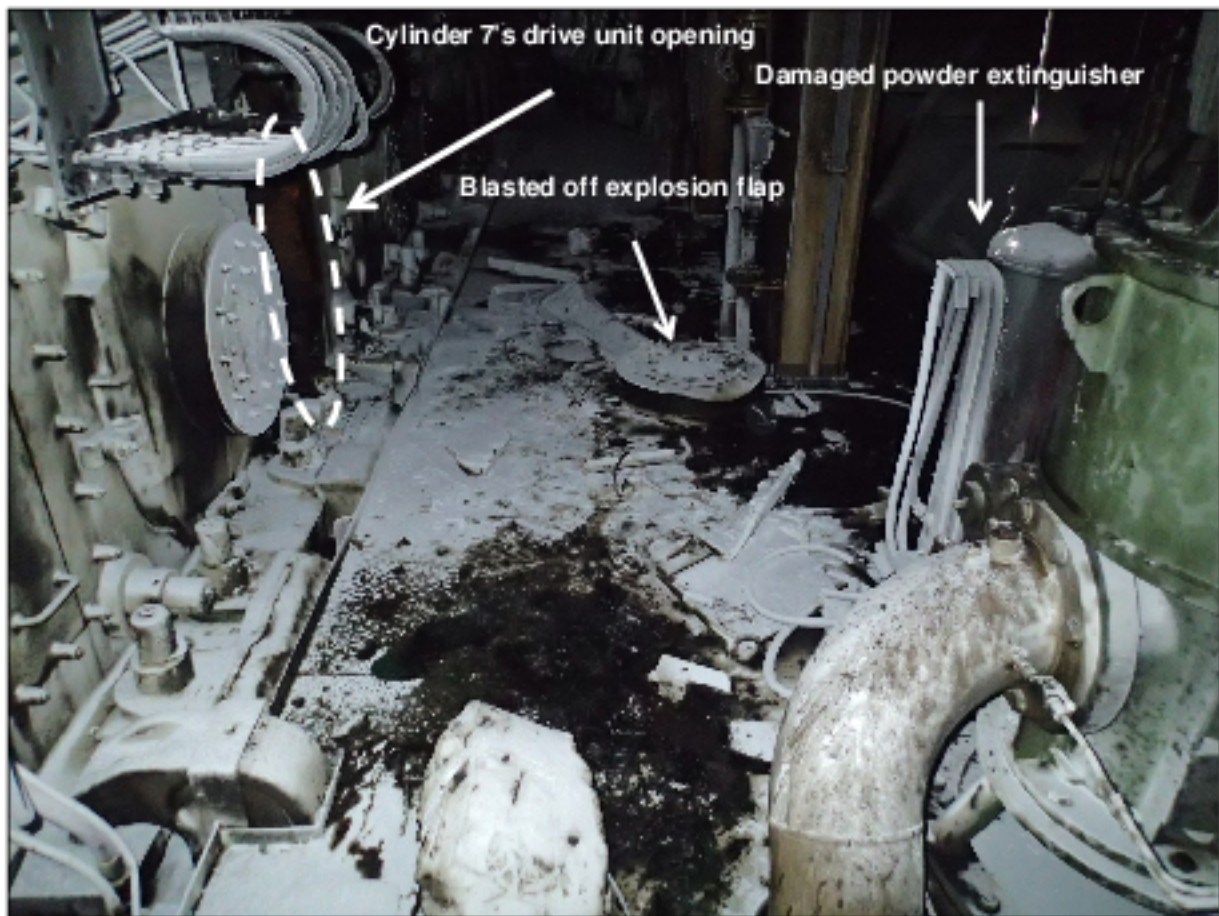
Figure 6: Debris in front of a drive unit opening belonging to cylinder 7  
(taken on 27 October 2015)

The THETIS D sustained heavy drive unit damage on the main engine. In addition to fractured drive unit parts on cylinder station 7, the engine frame was destroyed and parts of the unit had been ejected.

Parts of the connecting rod were 7 m away. A large amount of lubricating oil had escaped.

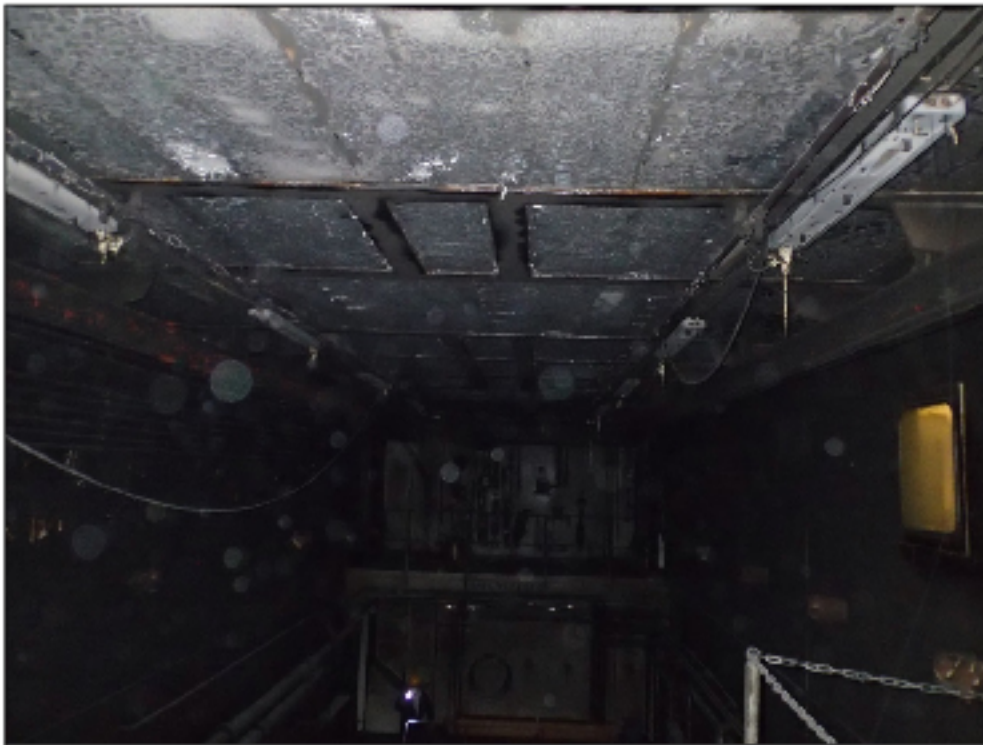
Figure 7: Traces of fire in the engine room

The entire engine room exhibited heavy fire damage (soot build-up, melted overhead lighting – see Fig. 7).

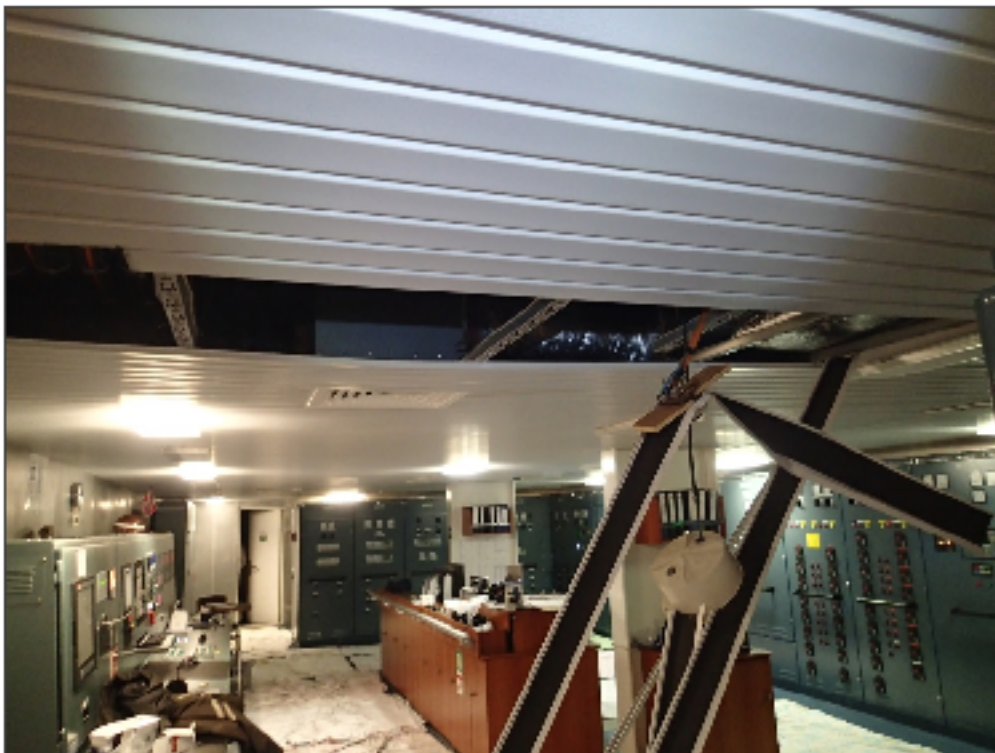
Figure 8: ECR with detached ceiling lining

No traces of fire were visible in the ECR, where only a part of the ceiling lining had loosened (see Fig. 8).

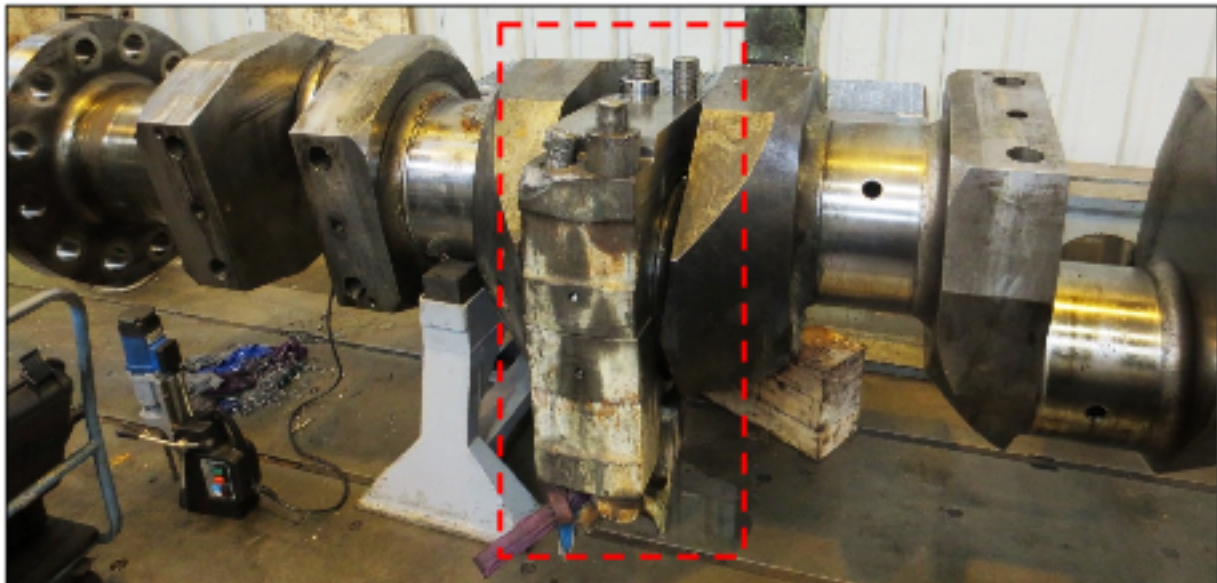
Figure 10: Damaged connecting rod bearing after the removal of the crankshaft

Part of the assessment included a visual inspection of the crankshaft on 7 December 2015. Furthermore, a surface crack test and a hardness test were carried out in the area of the crankshaft bearing pin 7. A protruding upper shell belonging to the connecting rod bearing was found during the examination, among other things. A further assessment of the connecting rod on 10 December 2015 revealed extremely pronounced signs of fretting<sup>4</sup> on the connecting rod shank's mating surfaces and on the connecting rod bearing cap. The materials laboratory suggested that these findings were indicative of a pre-stress loss in the corresponding bolt connection at the connecting rod's bearing bore.

Prof. Dipl.-Ing. Hark Ocke Diederichs assisted the BSU's investigation team in this safety investigation. The assessment centred on the examination of cylinder station 7's damaged connecting rod (see Figure 10).

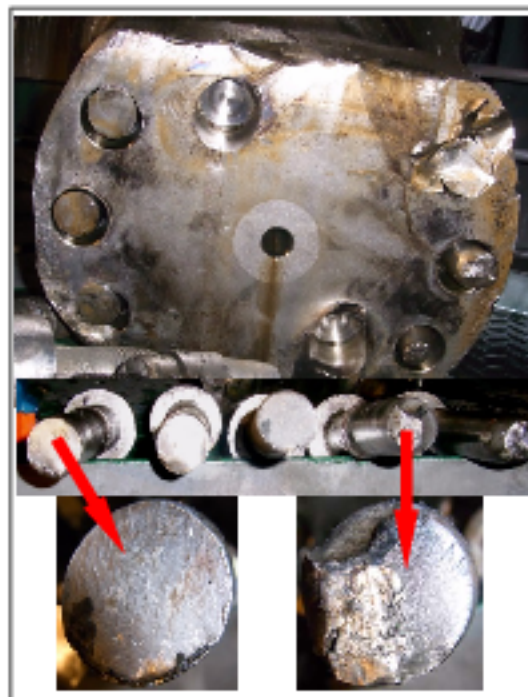
Figure 12: Broken bolts for the split shank

*[The small end bearing] is a single piece and pressed into the gudgeon-pin boss. The connecting rod bearing is in two parts with an upper and a lower shell, which is clamped in the bearing housing with four bolts. [...] The [THETIS D's] connecting rod has broken apart at the split shank and broken just above the connecting rod bearing.*

Three of the six connecting bolts for the split shank exhibit typical characteristics of a ductile shear stress break, the other three bolts a ductile bending forced fracture with lateral contraction. This suggests that the connecting rod was first kinked (bending forced fracture), and afterwards the separation surfaces shifted (sliding) and "cut" the other bolts as a result.

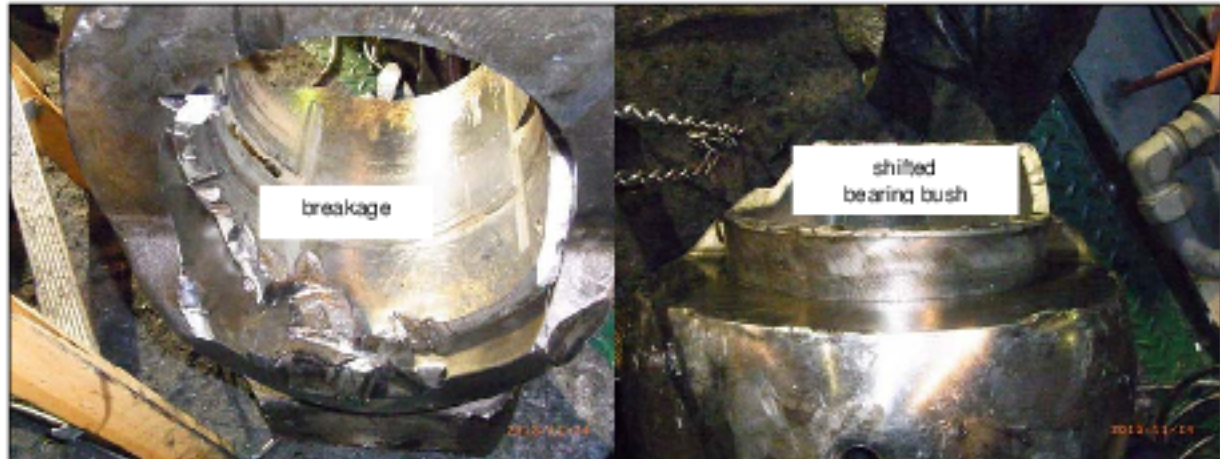
Figure 13: Connecting rod eye with breakage and laterally shifted bearing bush

Large pieces were broken out from the bearing bush in the connecting rod eye and the bush was pushed approx. 50 mm out of the bore. The connecting rod eye and bearing bush exhibit heat tones. [...]

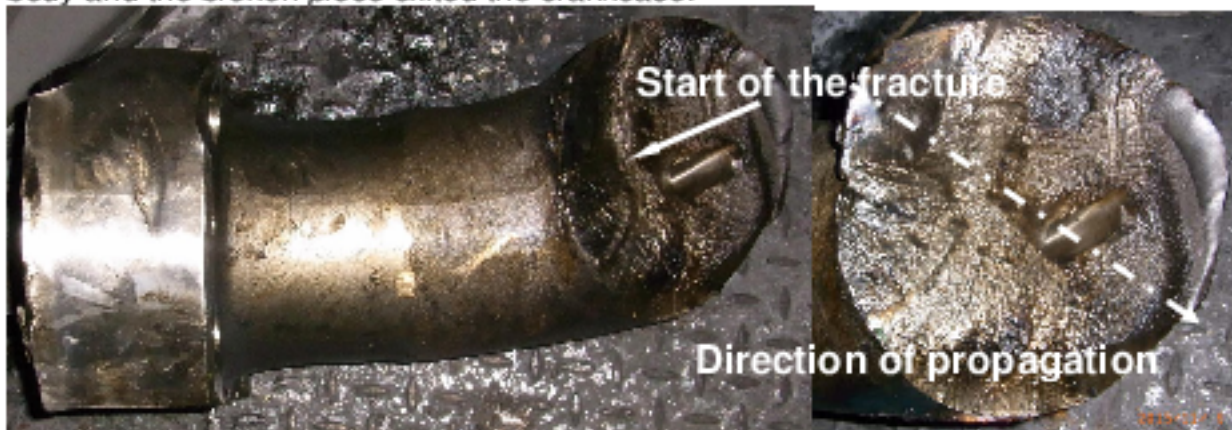
Figure 14: Broken connecting rod with detailed enlargement of the broken surface

The lower part of the connecting rod broke off directly at the transition to the bearing body and the broken piece exited the crankcase.

The broken surface exhibits the typical characteristics of a ductile forced fracture. It is noticeable that the fracture begins in the middle and then continues in a curve. This suggests that a compressive force and torsional force must have been applied at the same time."

After assessing the fracture patterns on the bolts, the expert arrives at the conclusion that the connecting rod fractured under great force due to buckling. This is reportedly only possible if the piston is blocked while moving upward.

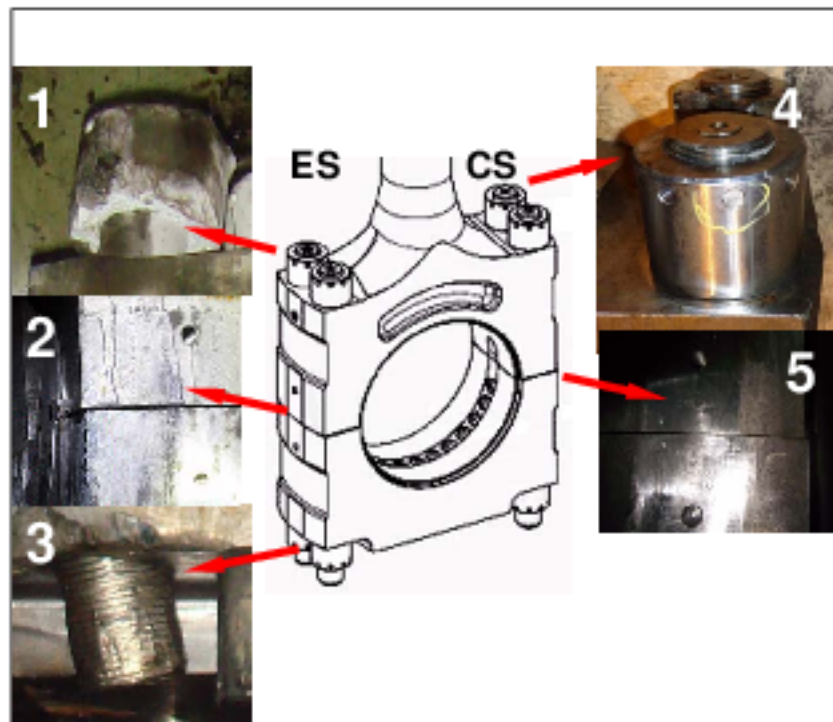
Figure 15: Visible external damage on the connecting rod bearing

*"The connecting rod bearing was fixed and would not rotate around the crank pin. It was not possible to measure the bearing play, but it could be felt to be large. The visible external damage is shown in [Figure 15; label ES = exhaust side, CS = control side]."*

- 1 *Ring nut fragmented and free end of thread bent.*
- 2 *Bearing shell squeezed out sideways, gap between bearing housing halves and shift of the housing halves*
- 3 *Bolt exited out of bearing housing*
- 4 *Broken rotating pin in the upper ring nut*
- 5 *Wedge-shaped gap between bearing housing halves*

- the serious engine damage was caused by low pre-stressing on the connecting rod bearing bolts;
- excessive wear on the connecting rod bearing occurred, subsequently resulting in deformation. This caused a reduction in bolt force, among other things;
- the engine's loss of power worsened due to increased friction in cylinder 7 (piston seizure), whereupon the automatic load governor had to increase the fuel supply to compensate for the reduced revolution rate, and
- the expert thinks it unlikely that previous damage to the bearing shells would have caused the present damage to the bearing.

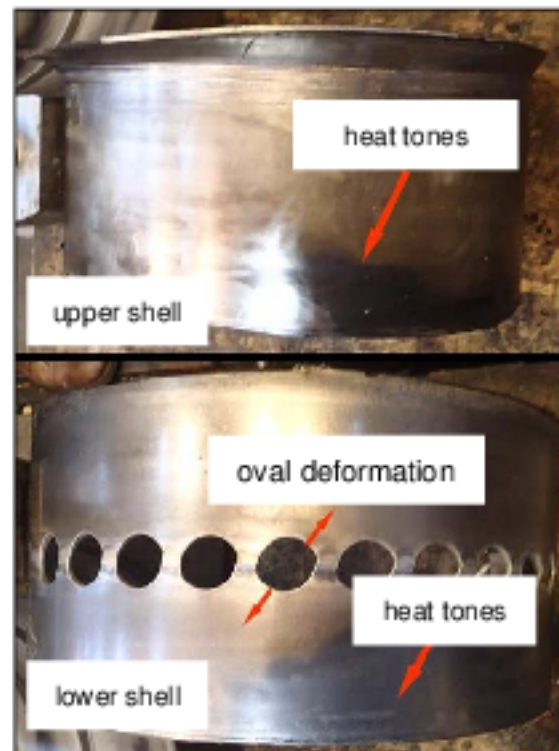
Figure 16: Rear side of the bearing shells

The expert was unable to find any scoring or other signs that were indicative of rotating bearings on the bearing seats or on the back of the bearing shells. According to his diagnosis, both bearing shells had been driven out of the bearing bore laterally and exhibited localised, blue discolouration. The bores in the lower shell exhibited oval deformation (see Figure 16), which permits the conclusion that misalignment had occurred.

***Even deformation of the bearing shells and thus even distribution of the compressive stress in the bearing shells are guaranteed only if the bearings are protruding evenly on both sides and all bearing shells are pre-stressed. Deviations from these two conditions can lead to unintended elastic/plastic deformation of the bearing shells during operation.***

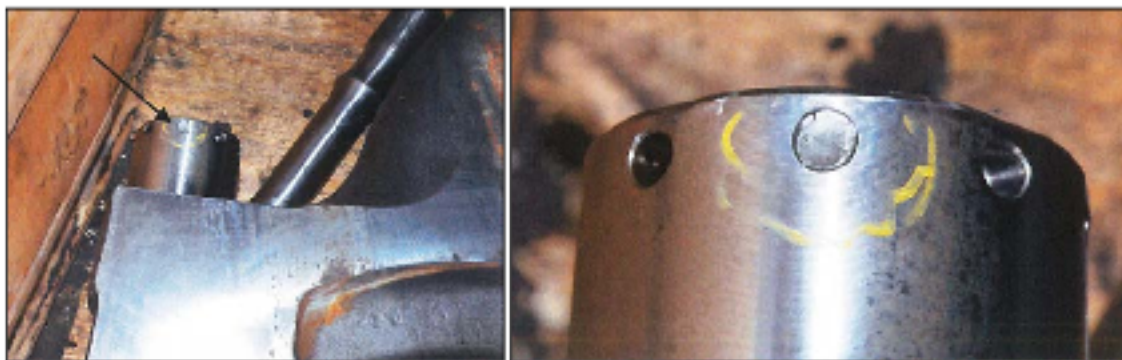
Figure 23: Broken tommy bar in one of the upper connecting rod nuts

Although the BSU's investigators did not receive any information regarding the exact procedure for inspecting the connecting rod bearing on the THETIS D, the bolted connections examined do permit conclusions as to the type and quality of the inspection by the then chief engineer officer. When examining the upper connecting rod nuts, it was noticed that one of the nuts still had a broken tommy bar in the bore (see Figure 23).

Tommy bars are used to tighten the tensioner nuts by hand. The tommy bar's diameter was 12 mm, meaning it could not have snapped due to manual tightening alone. The fragment found is thus an indication of the application of greater force, e.g. by lateral blows with a hammer.

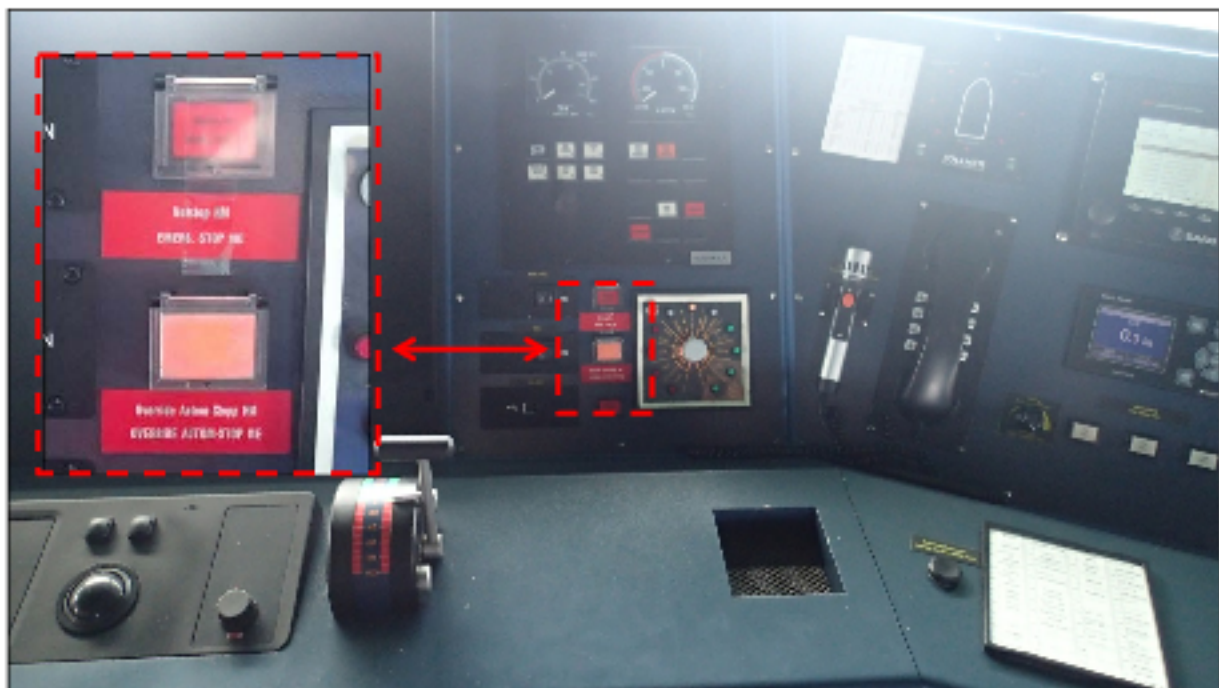
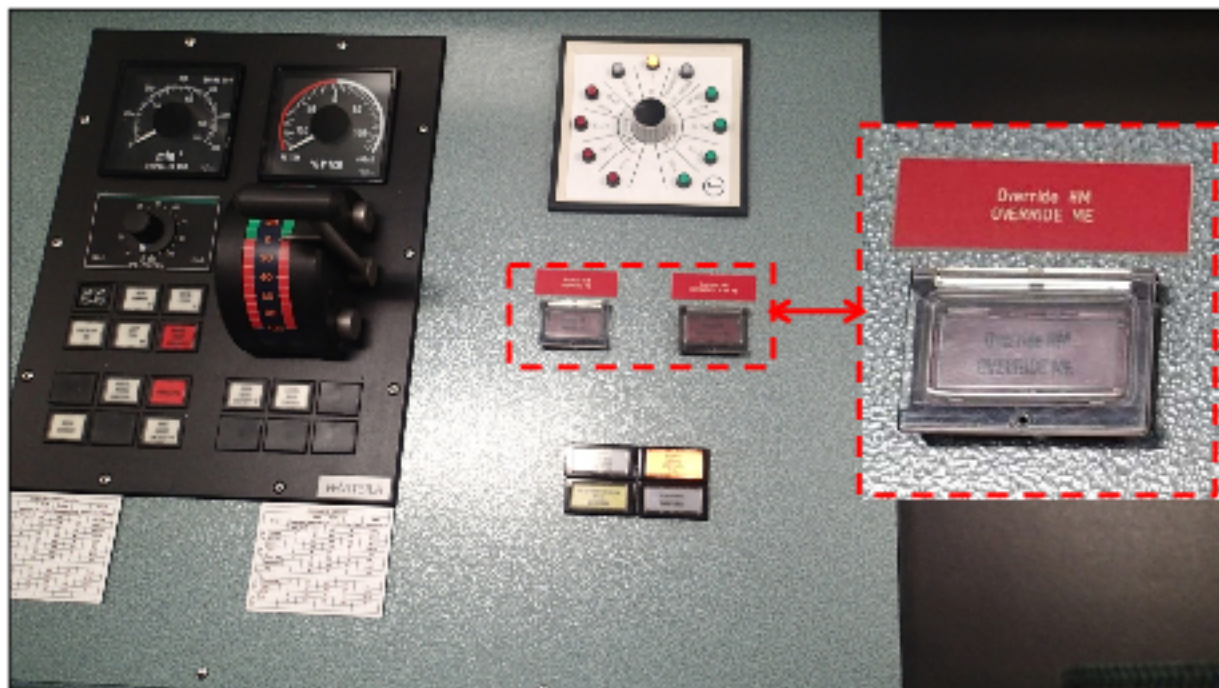
For example, it was evident that the ship's command of the THETIS D regularly enables override mode in estuary trading. Override is an emergency mode that can be enabled by pushbutton on the bridge and in the ECR. When override is enabled, the main engine is not stopped automatically if limits previously defined in the system are exceeded or not reached. The main engine's numerous safety systems are virtually cancelled out, i.e. the main engine continues to run unimpeded. The purpose of override is to keep the ship manoeuvrable in exceptional situations when greater risks would otherwise prevail.

The pushbutton on the bridge and in the ECR for enabling override mode is positioned next to the main engine's emergency shutdown and has a safety cover to prevent unintentional operation (see Figures 24 and 25).

We are all aware that other cargo ships with a four-stroke engine are also operated regularly in override mode when in estuary trade due to concerns that false alarms might impair manoeuvrability by stopping the main engine automatically. Regularly disabling the main engine's automatic emergency shutdown in estuary trading by pressing the override carries its own risks, however. Engine safety systems, such as drive chamber monitoring by oil mist detectors or the splash-oil monitoring system are rendered ineffective in dangerous situations. When asked about this misuse of the emergency system, the shipowner told the investigators that as a master he grounded because the ship's main engine stopped automatically. He explicitly approved of the practice of the masters engaged on the THETIS D of sailing with override. The THETIS D was initially sailed with override enabled after casting off in Gdynia on the day before the accident, too. This was disabled again during the sea passage, however. The decision to enable override mode always rests with the ship's command. Regardless of that, the BSU's investigators consider it necessary to draw attention to the above risks.
