Investigation Report 431/15

**Serious Marine Casualty**

**Serious engine damage  
followed by fire  
on board the cargo vessel THETIS D  
on 26 October 2015  
in the Kiel Bight**

14 June 2018

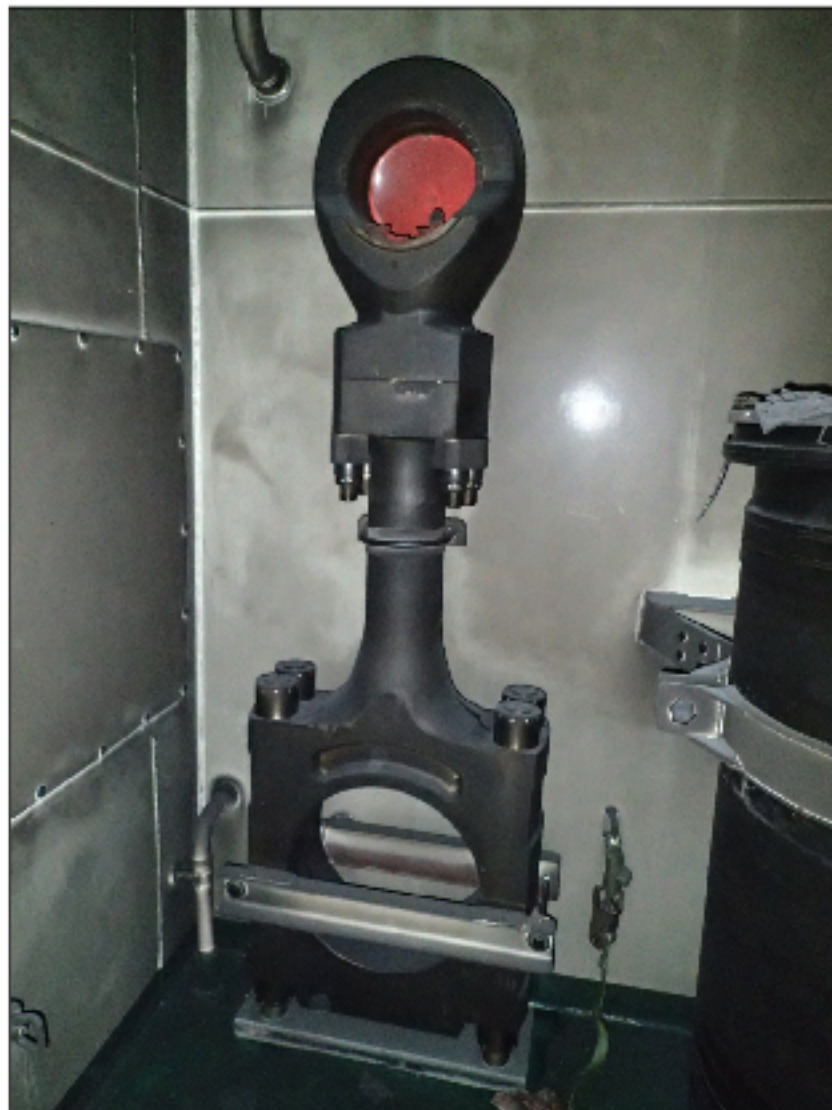
Figure 9: Replacement connecting rod in the THETIS D's engine room

A replacement connecting rod was carried on the THETIS D (see Fig. 9), meaning exchanging it would have been possible if necessary.

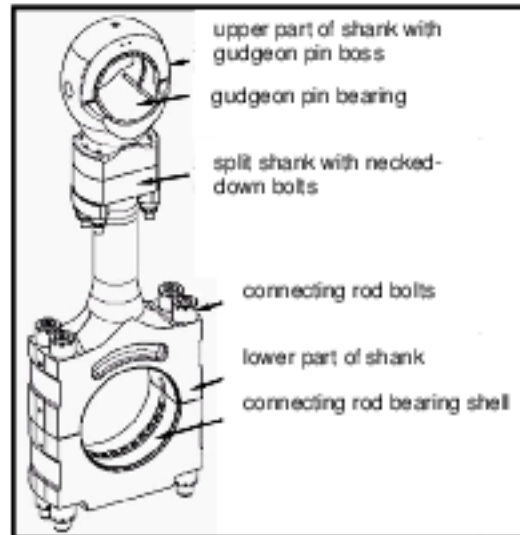
Figure 11: Technical drawing of the connecting rod

*"The split connecting rod consists of the upper part with a connecting rod eye and the lower part with the connecting rod bearing. Both parts are connected to each other on the split shank with six necked-down bolts."*

*[The small end bearing] is a single piece and pressed into the gudgeon-pin boss. The connecting rod bearing is in two parts with an upper and a lower shell, which is clamped in the bearing housing with four bolts. [...] The [THETIS D's] connecting rod has broken apart at the split shank and broken just above the connecting rod bearing.*

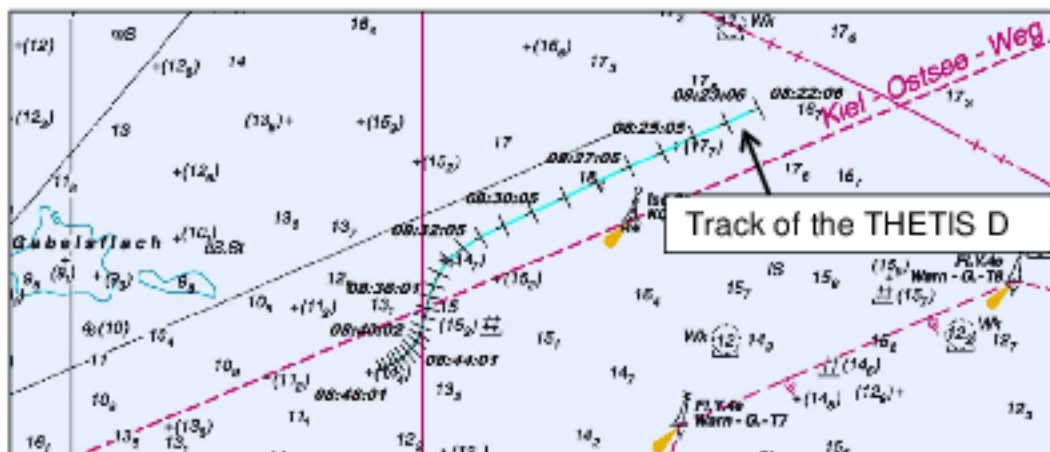
Figure 17: Course of the voyage taken by the THETIS D

The course of the voyage shows that the THETIS D started to cross the Kiel-Baltic Sea route separation line at 0837 and then drifted NUC against the recommended direction of the Kiel-Baltic Sea route in the German Exclusive Economic Zone of the Baltic Sea.

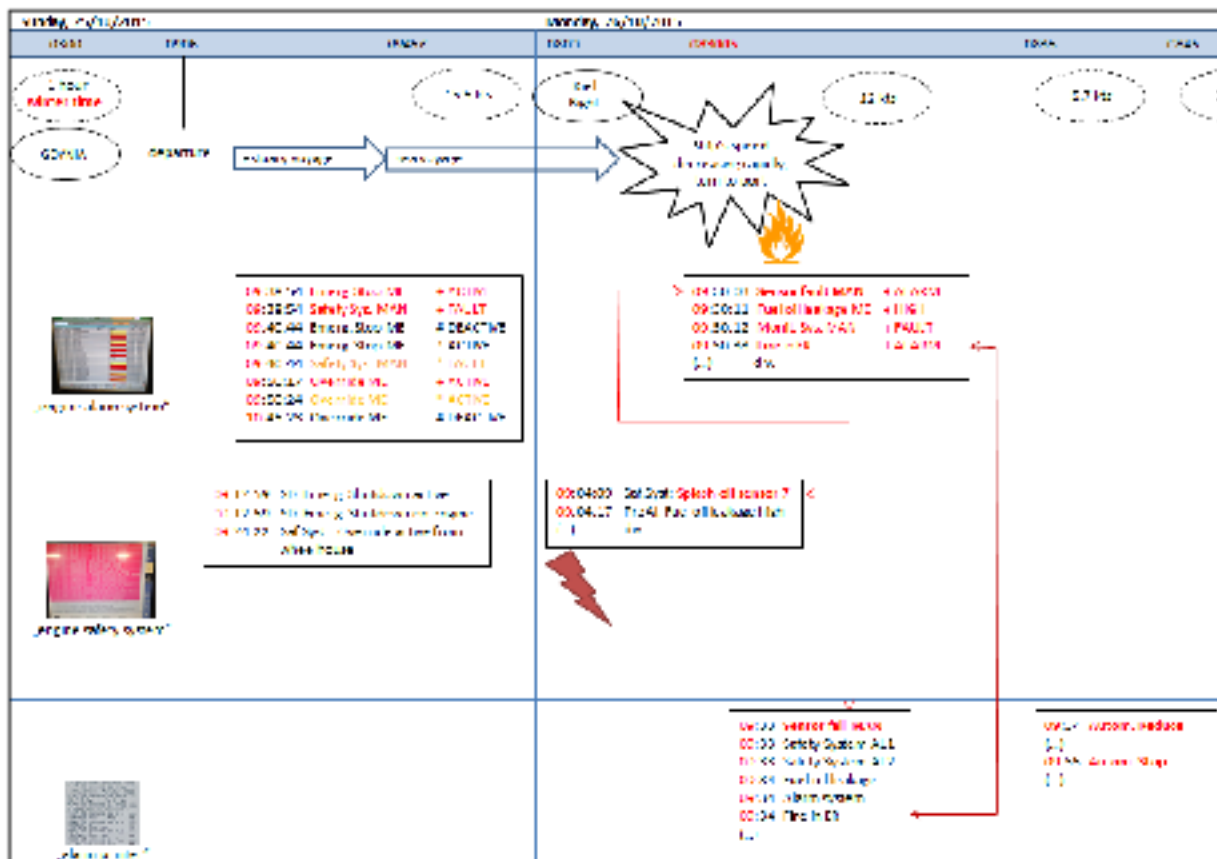
Figure 18: Engine alarms occurring at the time of the accident, extract from the BSU's graphical presentation

Reconstructing the course of the accident using alarm records from the THETIS D's ECR proved difficult. Some of the recordings of the various safety systems were only partially available and their entries differed from one another significantly. For example, the engine safety system recorded a splash-oil alarm for cylinder unit 7 26 minutes<sup>9</sup> before the accident (see Figure 18<sup>10</sup>).

On the other hand, explaining the timing differences of the alarms recorded by the engine safety system was not so easy (see Fig. 18 on p. 29; synchronised to local time below):

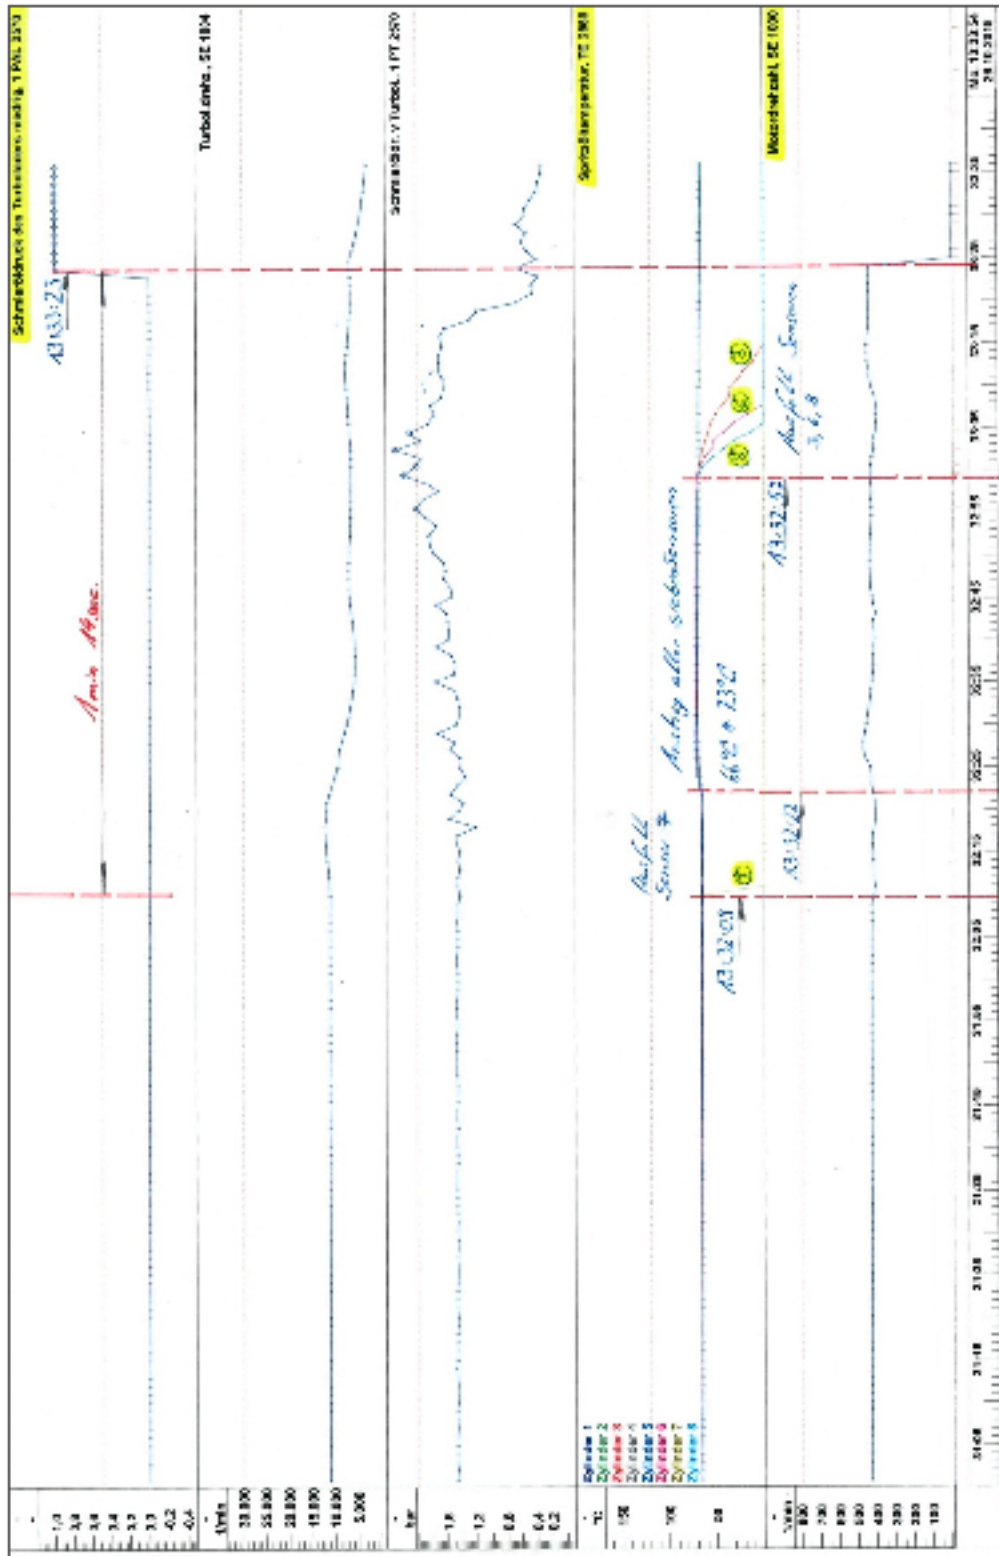
Figure 19: Extract from the manufacturer's diagnostic system for the main engine (splash-oil temperature and lubricating oil pressure in the turbocharger)

According to the configuration, the splash-oil monitoring system would have stopped the main engine with a delay of only 1.7 seconds if one of the two critical criteria had been met. This means that the main engine could not continue to run for several minutes after the damage occurred if the splash-oil monitoring system was functioning as it should. To prove serviceability, the BSU was submitted an extract from the manufacturer's own diagnostic system for the main engine in November 2016 (see Figures 19 and 20). The system time in the recordings deviates from local time by + 5 hours (13xx instead of 08xx). According to the recordings, the sensor in cylinder 7 failed initially. This was followed by a simultaneous increase in splash-oil temperature from 66°C to 73°C in the other sensors, before the sensors from cylinders 3, 6 and 8 also failed. The automated shutdown of the main engine

was triggered by insufficient lubricating oil pressure in the turbocharger before other safety systems were able to have any affect.

The documents show that at the time of the automated engine shutdown, neither of the two conditions (temperature 80°C or temperature difference +3 K) that would have prompted the splash-oil monitoring system to trigger the engine shutdown were met. The monitoring system for the turbocharger lubricating oil pressure was calibrated so that a drop in pressure to 0.9 bar would cause an automated engine shutdown. According to the recordings of the diagnostic system, this criterion was met at 083323, therefore causing the engine shutdown. Taking into account the time difference of + 5 hours, the documented time is consistent with the recordings on board (engine alarm system and alarm printer, recorded in UTC + 2 h) and the shore-based AIS recordings of the VTS (including SOG, recorded in UTC + 1 h) – see Spreadsheet 4 with synchronised times for ease of reference; all information in UTC + 1 h = local time.

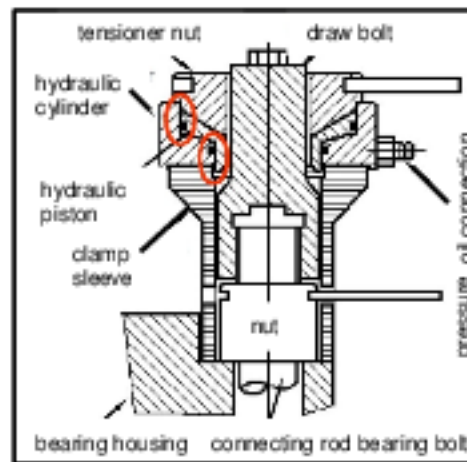
Figure 21: Hydraulic tensioning tool (schematic drawing)

The tightening of connecting rod bearing bolts as per the manufacturer's instructions required the use of hydraulic tensioning tools connected to a high-pressure pump (see Figure 21). The manual states the following with regard to functioning:

"The high pressure pump feeds a relatively small volume of liquid (if required, at a pressure of up to 1,500 bar) through the pluggable hose lines to one or more tensioning tools. If the piston of the tensioning tool is screwed onto the thread of the screw, the liquid raises the piston in the casing and extends the screw, whilst the tensioning tool is supported by the surrounding parts of the screw. The high pressure pump is operated by compressed air. The air is directed through control elements to a piston. This piston can be pressurized from both sides and is equipped with pistons of smaller diameter on both sides which draw in hydraulic oil from the surrounding reservoir, or which feed it to the distributor on the opposite side. As soon as the piston reaches an end position, the air flow is directed to the other side of the piston by a pilot valve, and the pumping and suction action is repeated. The effective pressure of the air is normally reduced in order to produce a pressure of 1,500 bar on the hydraulic side. An outlet pressure of 1,500 bar must not be exceeded."
